PRODUCT MODIFICATION NOTICE: TRILENNIUM® HANDSET UPDATES

Endura Products has implemented several modifications to our Trilennium (formerly W&F Hardware) Handsets for the Trilennium Multi-Point Locking System. These modifications serve to improve performance and durability of the product over time based on observed field conditions and feedback, and are either effective immediately or in the near future as part of a rolling change.

Handsets Affected: Eclipse, Eclipse Grip, Pinnacle, Curved and Rectangular. Horizon is **NOT** impacted.

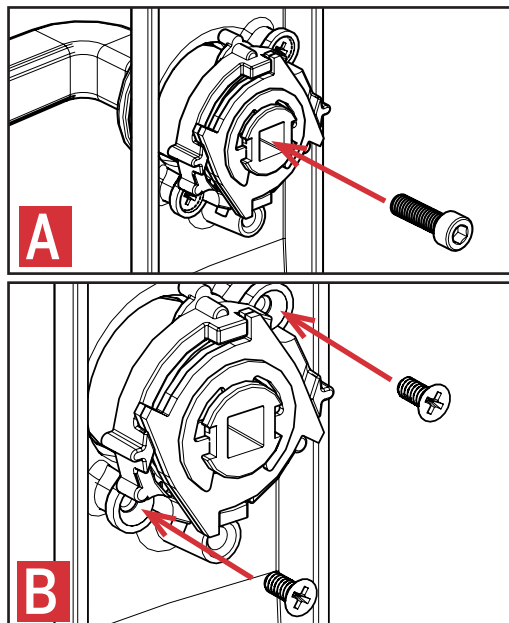
EFFECTIVE IMMEDIATELY: LEVER/CARTRIDGE SCREW MODIFICATIONS**FIELD CONDITION: LOOSE/"WOBBLY" HANDSET LEVER HANDLE**

Handset lever handle felt loosely secured to the escutcheon. In these cases, one of two issues was present: either the handle was loosely secured to the cartridge (addressed in solution A below) or the cartridge was loosely secured to the escutcheon (addressed in solution B below).

- A. The **handle mounting screw**, used to secure the lever into the cartridge, **(A)** has been shortened from 3/4" to 5/8". This modification prevents the screw from bottoming out inside the lever handle, which can cause the observed "loose" fit against the cartridge.
- B. The **cartridge mounting screws**, used to secure the cartridge to the escutcheon **(B)**, have been modified and now feature locking patches to improve their hold.

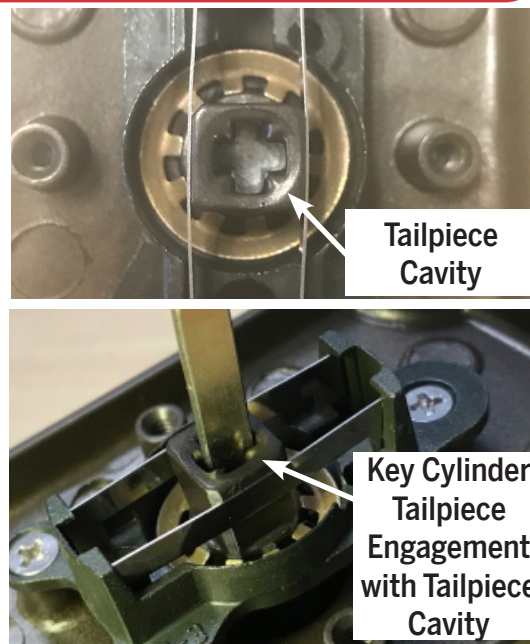
**EFFECTIVE IMMEDIATELY: ENHANCED THUMBTURN ENGAGEMENT****FIELD CONDITION: THUMBTURN TURNING BUT NOT ENGAGING BOLTS**

In some instances, turning the thumbturn did not result in turning the tailpiece of the key cylinder, which drives the dead-bolting action of the lock (the thumbturn was slipping around the end of the key cylinder piece). This prevented users from unlocking and locking the door from inside the home.

We discovered that in these specific cases only, the tailpiece cavity located on the interior of the thumbturn was washed out, worn out or out of spec. Additionally, the key cylinder tailpiece's tapered end design further reduced its ability to engage with the thumbturn, further contributing to the observed problem. While uncommon, when these factors were present, it made it difficult or impossible in some situations for the tailpiece to react based on the thumbturn's motion.

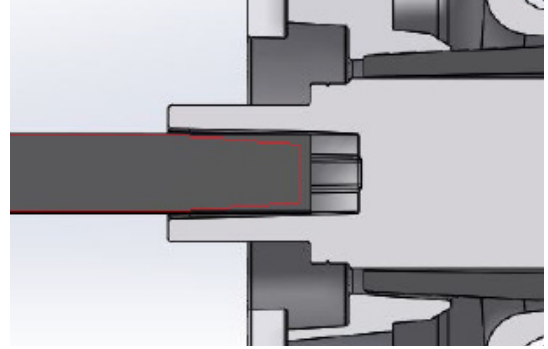
Previous Tapered-End Key Cylinder TailPiece (red outline) vs. NEW! Square-End & Longer Key Cylinder Tailpiece.

- Effective immediately, all thumbturns with an out of spec "tailpiece cavity" have been pulled from production.
- In the near future (3-4 months), as part of a rolling change, all Trilennium thumbturns will boast a narrower tailpiece cavity, and all key cylinder tailpieces will be 0.60" longer and feature a square vs. tapered design for better engagement and consistent operation over time.
